UNITED STATES SENATE
COMMITTEE ON ENERGY AND NATURAL RESOURCES
SUBCOMMITTEE ON WATER AND POWER

TESTIMONY OF CHARLES KIELY
ASSISTANT GENERAL MANAGER
DISTRICT OF COLUMBIA WATER AND SEWER AUTHORITY

THURSDAY JULY 25, 2013 AT 2:30 P.M.
DIRKSEN SENATE OFFICE BUILDING, ROOM 366

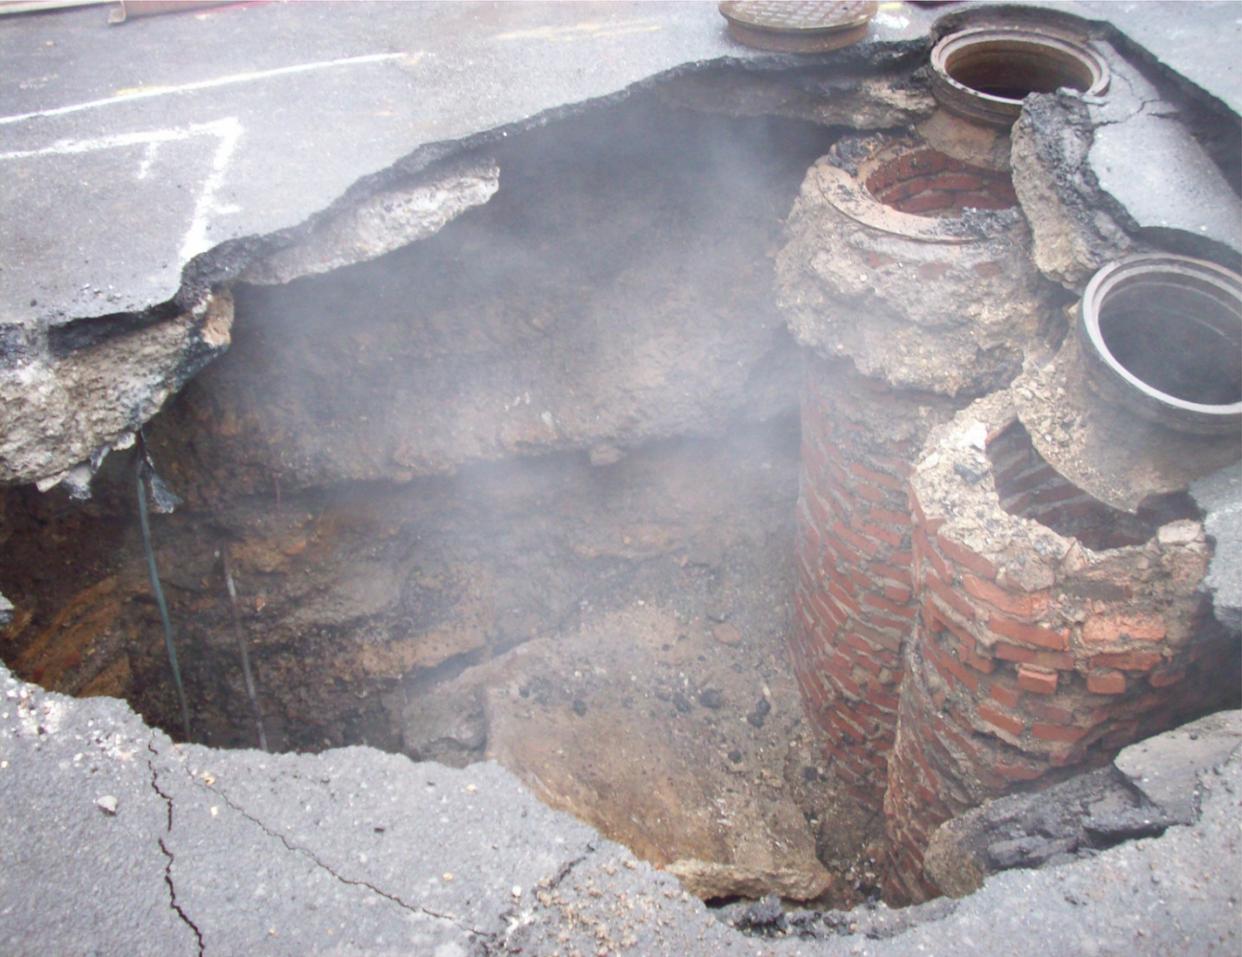
Damaged Sewer – Spring Place NW, December 2009
